## National road, Mörschwil (CH)

### Flexural reinforcement / Reinforcement of a prestressed bridge girder

Location: Mörschwil, Switzerland

Year: 2020

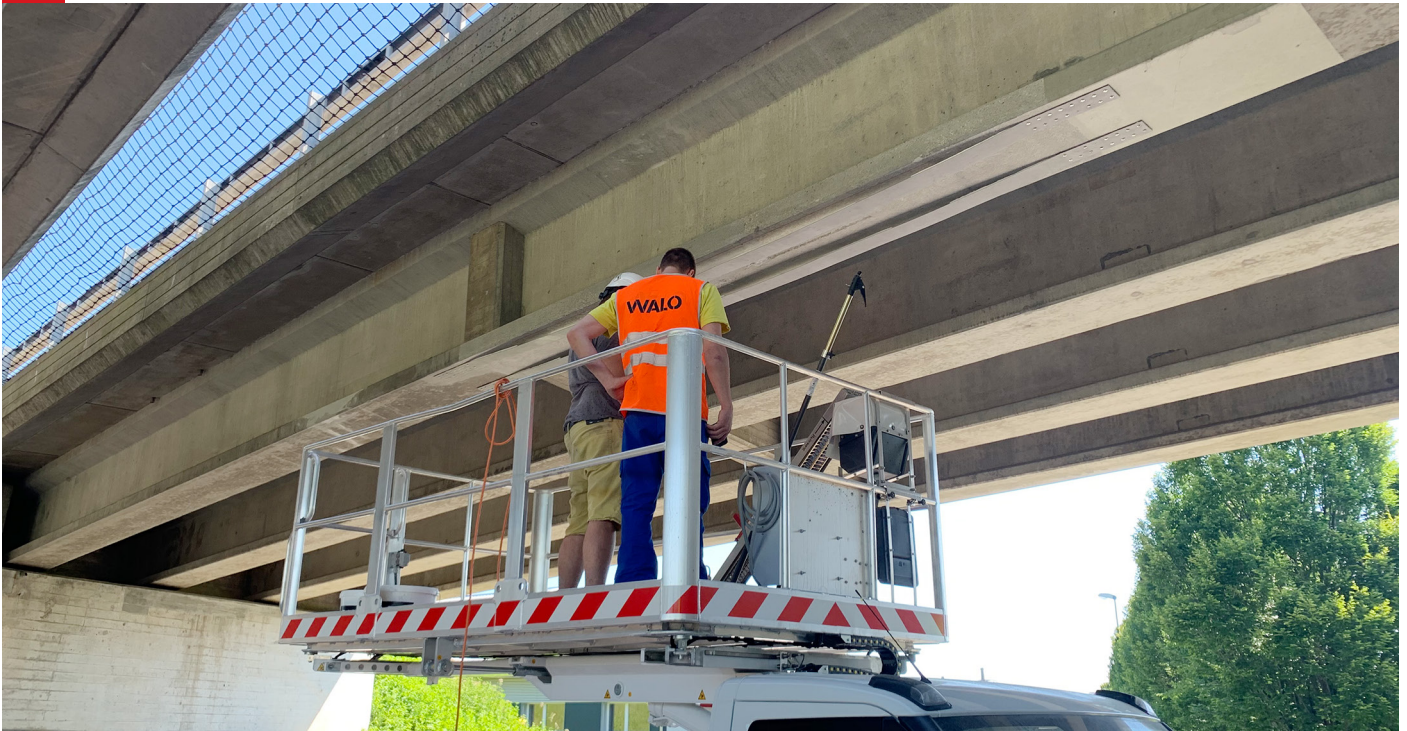
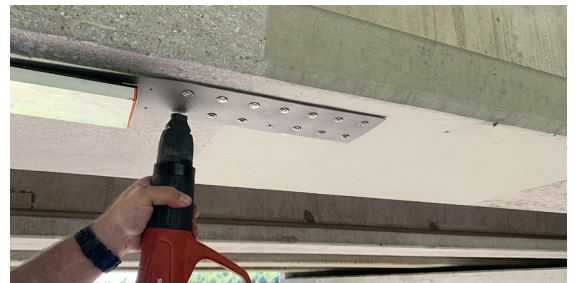
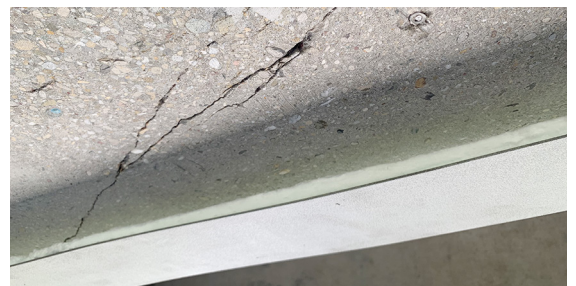
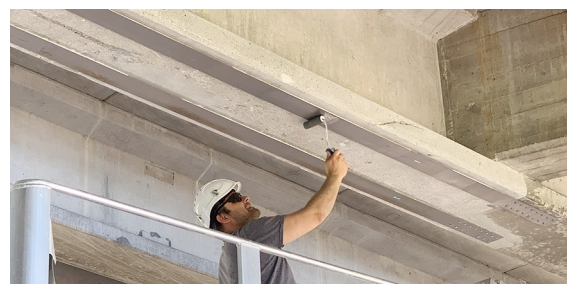
A bridge girder was locally damaged by road traffic and prestressed strands were damaged. Within two hours the reinforcement was performed with re-plate. The traffic flow was temporarily diverted to the second lane. This procedure is possible with re-plate because the system can be applied very quickly and efficiently. Since salt is spread on the freeway in winter to prevent ice formation, an increased chloride concentration might occur. Hence, a corrosion protection was already applied to re-plate in the factory. The activation was done with the infrared radiator and the heating temperature was limited to 165°C. Activating the re-plate with moderate heating temperatures has no negative effect on the SikaCor® EG-1 coating. The pretensioning force of re-plate is accordingly limited to 54 kN.
